TRAIL AND CAMPSITE EROSION SURVEY FOR GREAT SMOKY MOUNTAINS NATIONAL PARK

Part III: The Condition of Trails

RESEARCH/RESOURCES MANAGEMENT REPORT No. 16

Susan Power Bratton
Matthew G. Hickler
James H. Graves

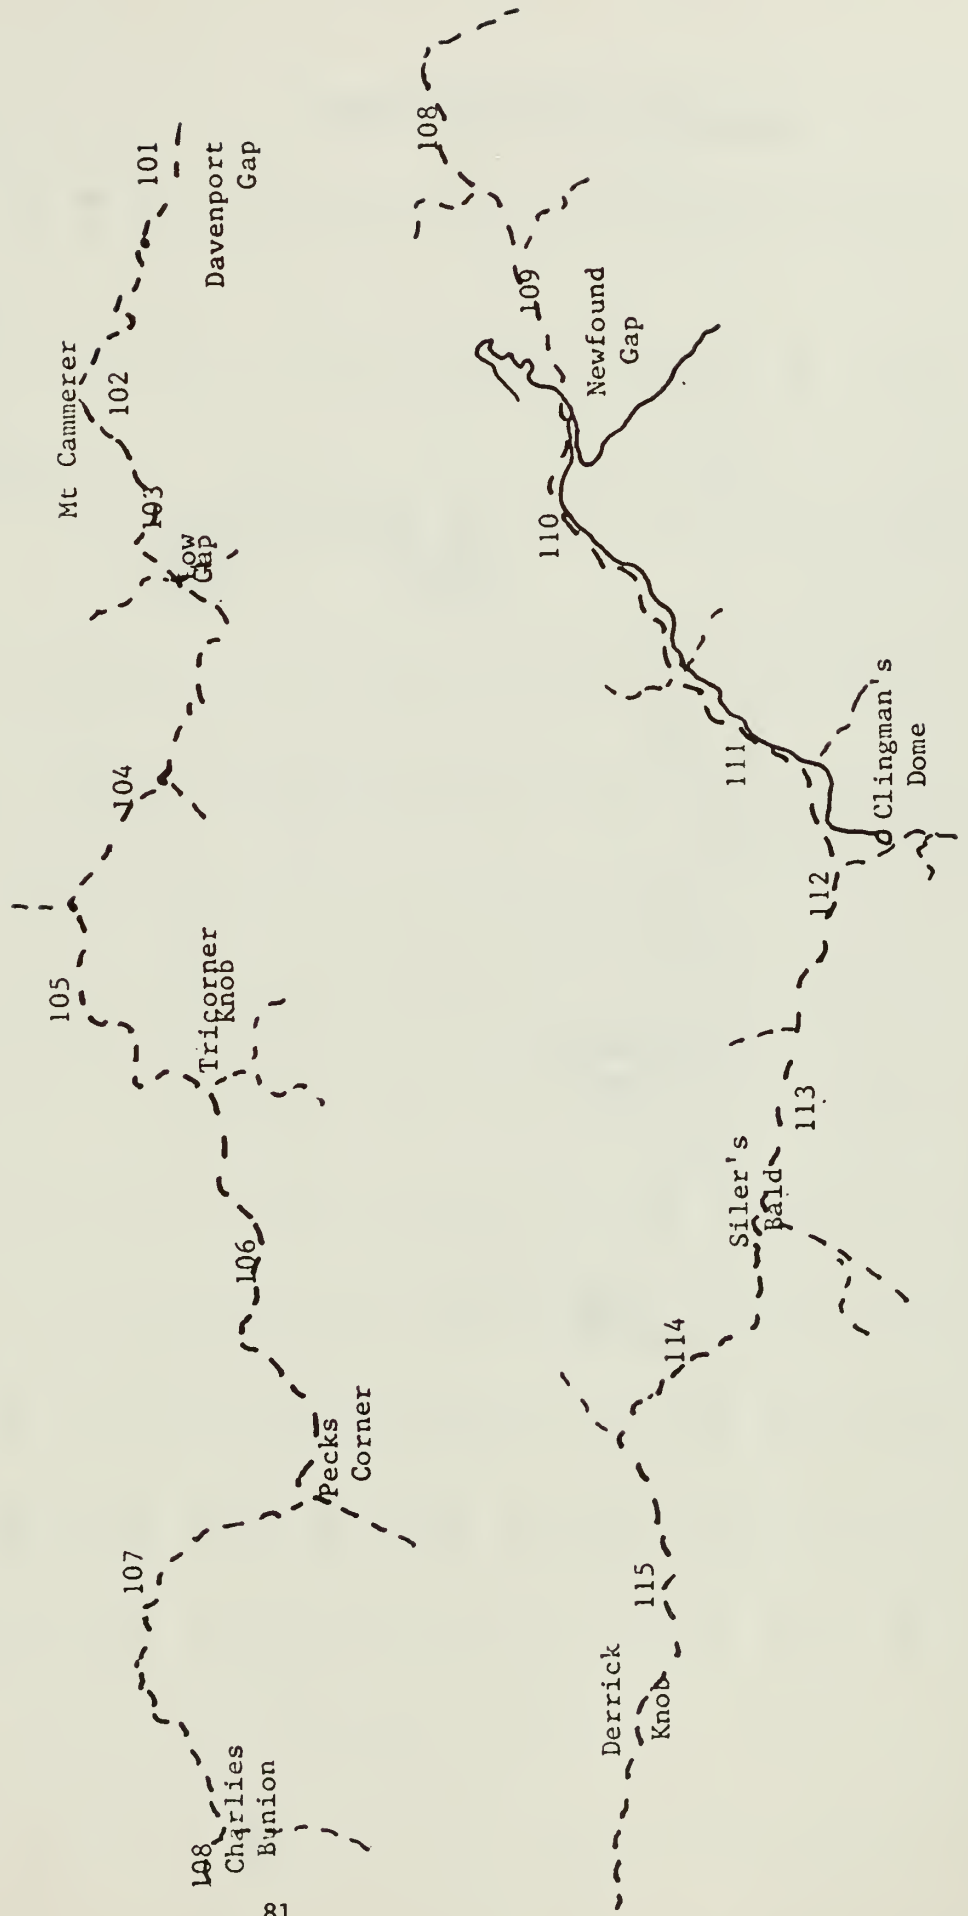
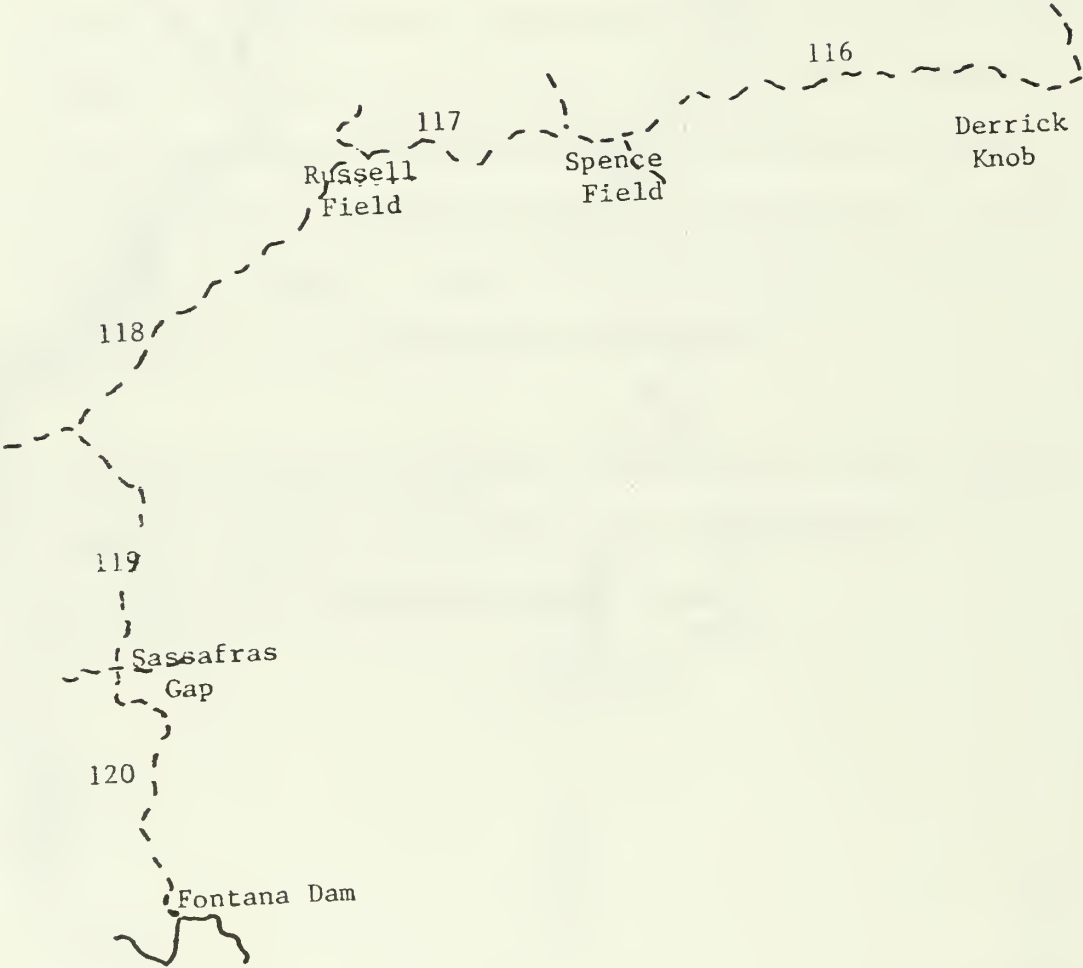
SECTION 1 - APPALACHIAN TRAIL

The trail improves at either end but is nowhere in better than fair condition. Rut and mud damage is very high around the Dome, and rut is important on the stretch between Derick and Silers. Exposed roots are a severe problem throughout.

This whole trail is in such poor condition that a look at the individual sections on the table following is necessary to distinguish the most severe problem areas.

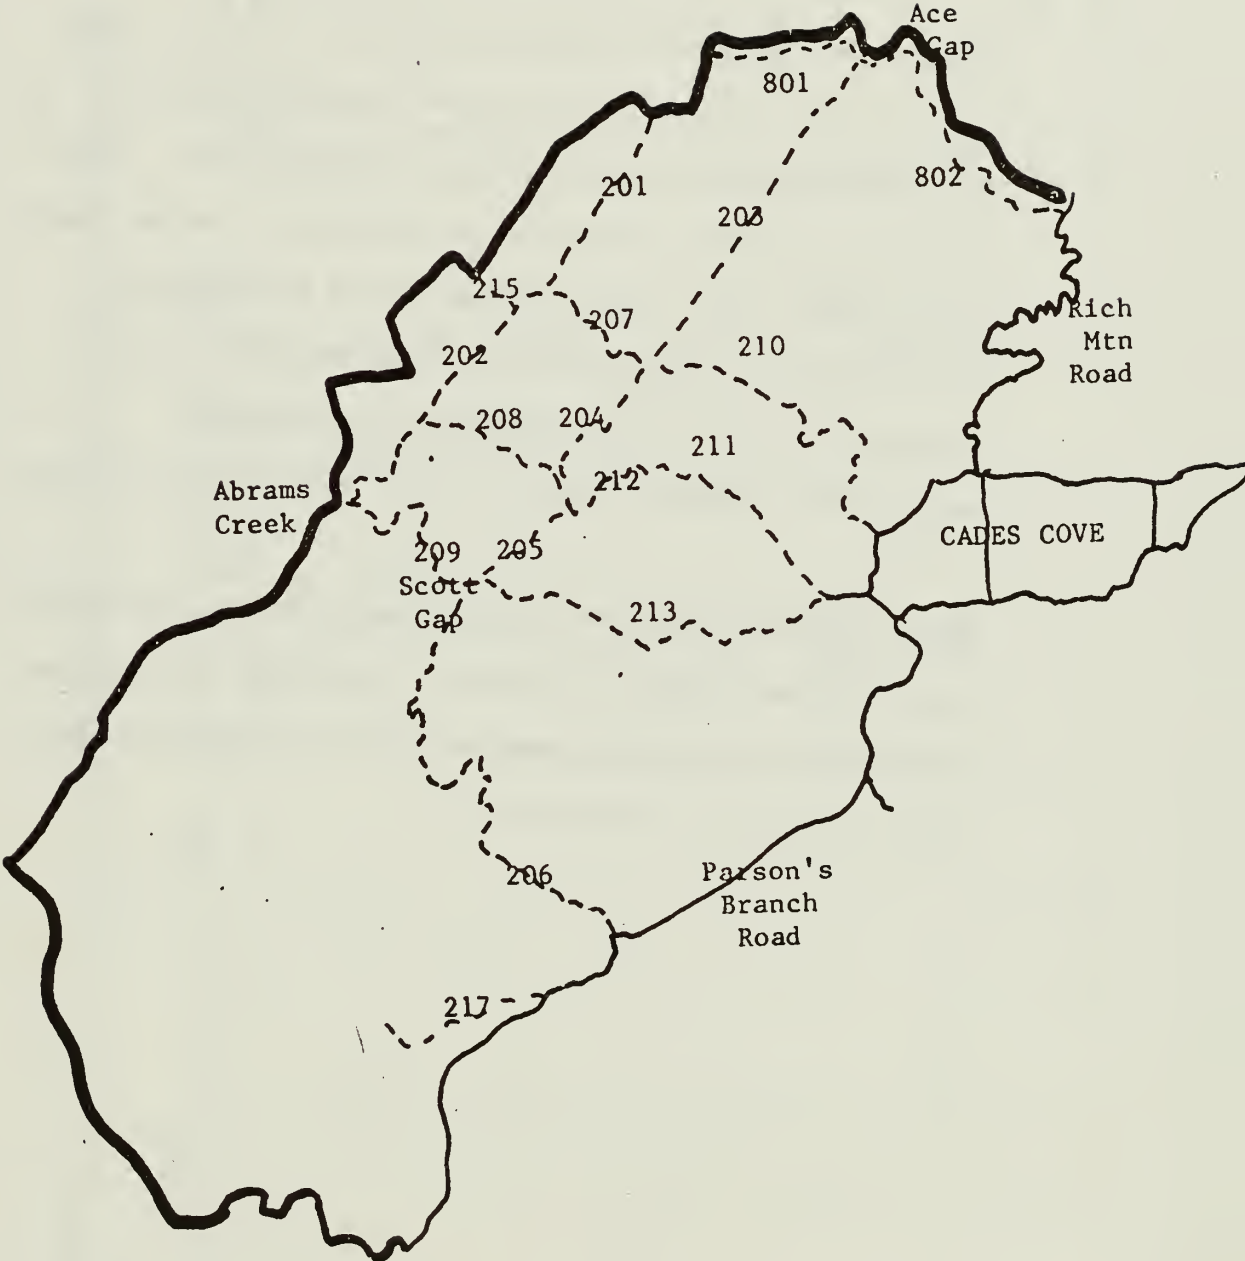
SECTION 2 - ABRAMS CREEK

The poorest trail in the Abrams Creek area is the one from Cades Cove to Abrams Fall and Hannah Mountain. The trail is very worn and has a high percentage of exposed rock. Beard Cane (201) has some problems with rut and mud, and the lower end of Rabbit Creek Road (213) has severe water erosion problems and a large eroded area. The remainder of this section is in good to fair condition, and moderate maintenance to control water and bank erosion should suffice.

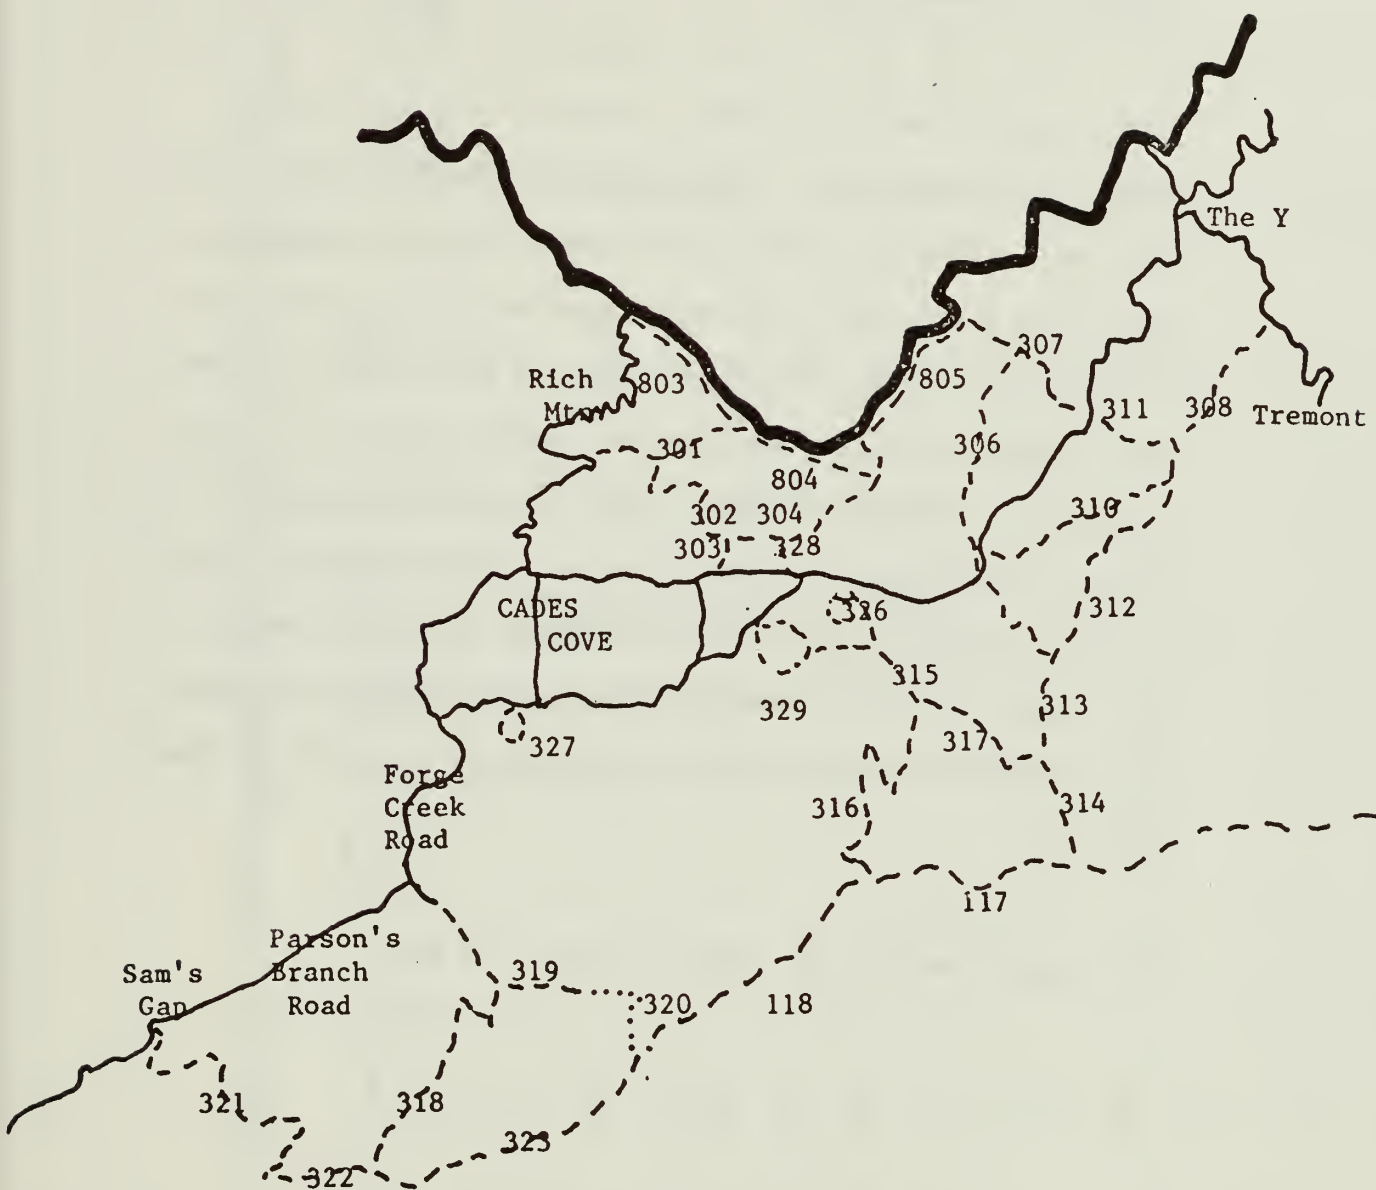
SECTION 3 - CADES COVE

Cades Cove section has a number of poor trails and has very heavy use in some areas. The loop to Rich Mountain Tower has mud, rut, and water erosion on the lower sections (Crooked Arm (304), the trail (302) from Indian Gap Road to the John Oliver cabin, and the lower connecting trails to the stables). Upper Bote Mountain (314) has problems with water erosion, mud, and horse plow. Anthony Creek Road (315) has some problems with horse plow and water erosion. The trail (316) to Russell Field (Ledbetter Ridge) has mud, water erosion, and horse plowing. The trail (322) across Gregory Bald is badly rutted, and there are severe problems with water erosion in the vicinity of Sheep Pen Gap.

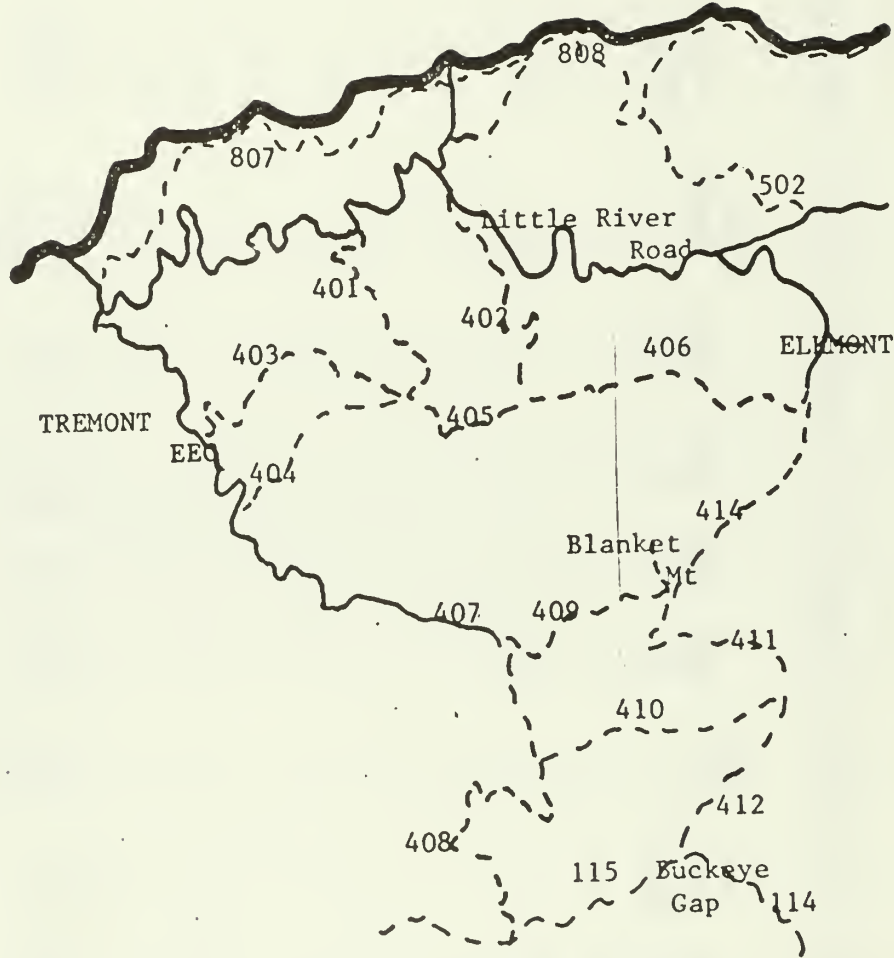
SECTION 4 - TREMONT

Most of the trails in this area are in fair to good condition. Mild water erosion is affecting the surfaces somewhat throughout the area. The trail (409) approaching Jakes Gap from Tremont Road, and the trail to Blanket Mountain (415) both have water erosion and exposed roots. The trail (408) to Derrick Knob also is approaching capacity of use, but has no exceptionally severe problems.

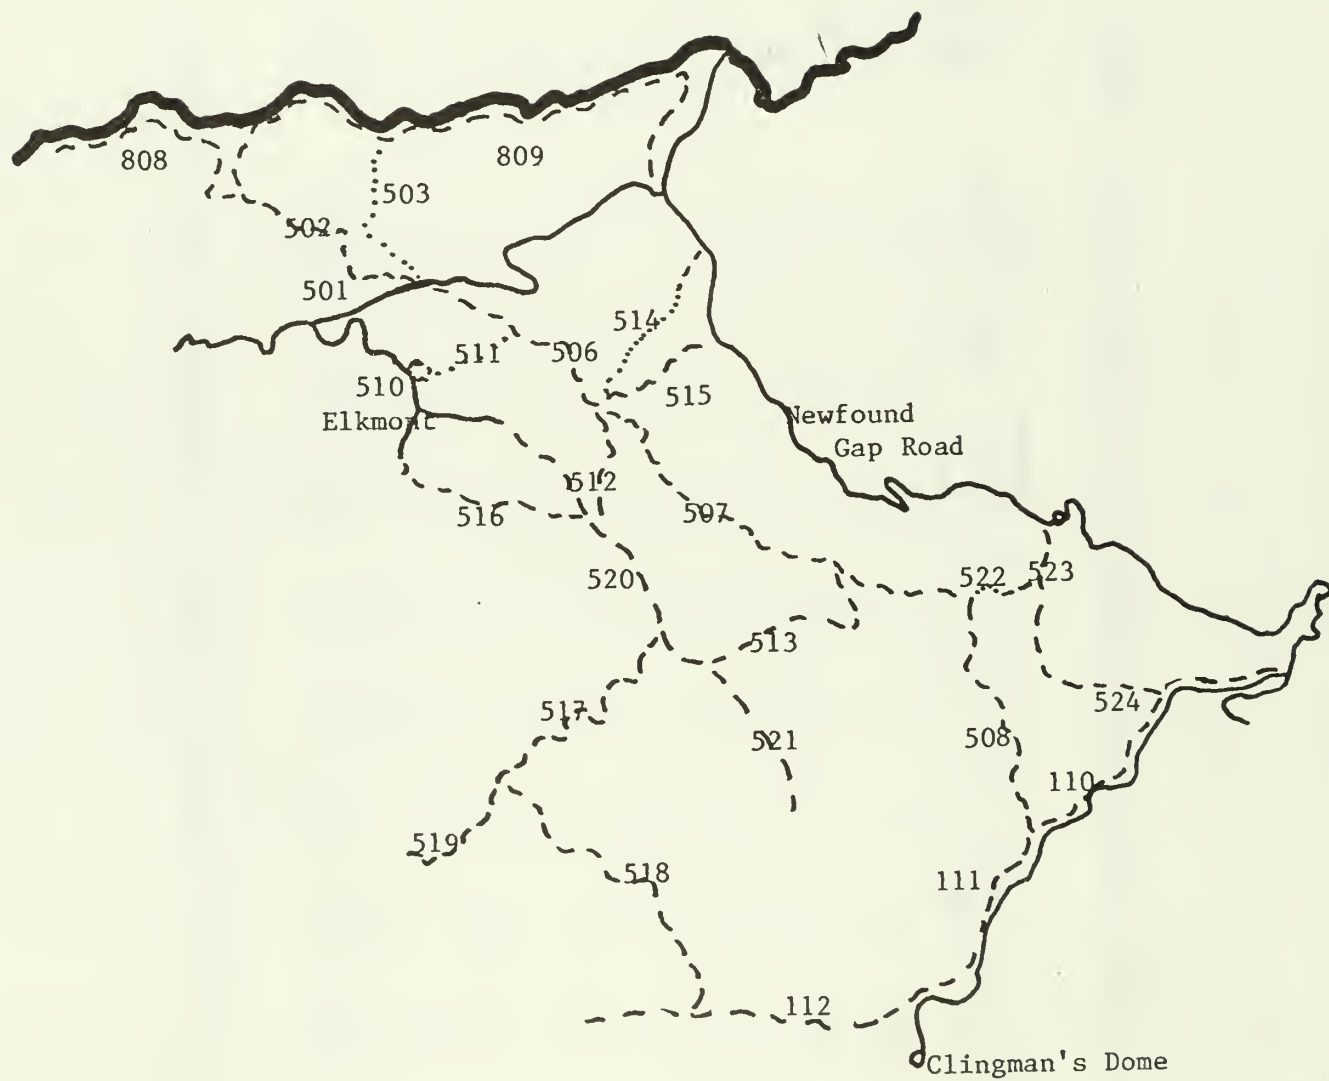
SECTION 5 - ELKMONT

Most of the problem areas in Elkmont section are in the Chimney Tops area, which is largely spruce-fir forest. The upper end of Goshen Prong trail (578) is water eroded, rutted, and has a problem with exposed roots. The trail to Chimney Tops (523) and the old Indian Gap Road (524) have water erosion, widening, and other typical high elevation, high use problems. The manway from Chimney Tops to Sugarlands Mountain (522) is one of the worst sections of trail in the park. It is muddy and the surface is water eroded with a few exposed tree roots.

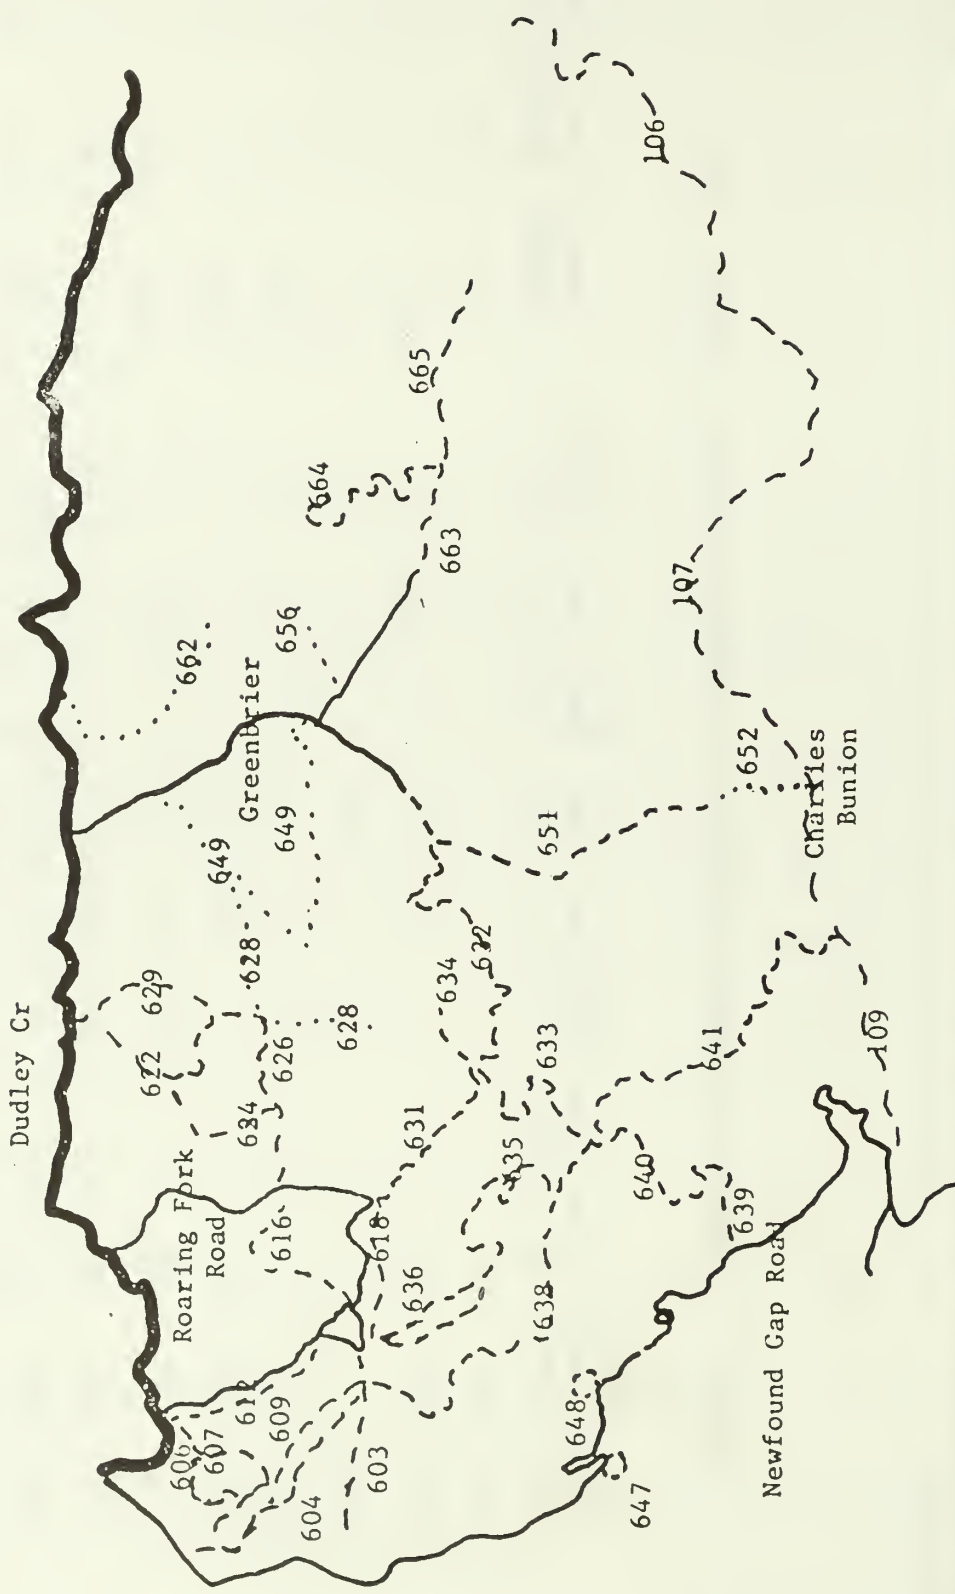
SECTION 6 - LECONTE

The LeConte section is one of the worst in the park and has very few maintained trails in good condition. (Note on the erosion and overall ratings that Jim Graves surveyed most of this section and tended to overrate relative to the other surveyors.)

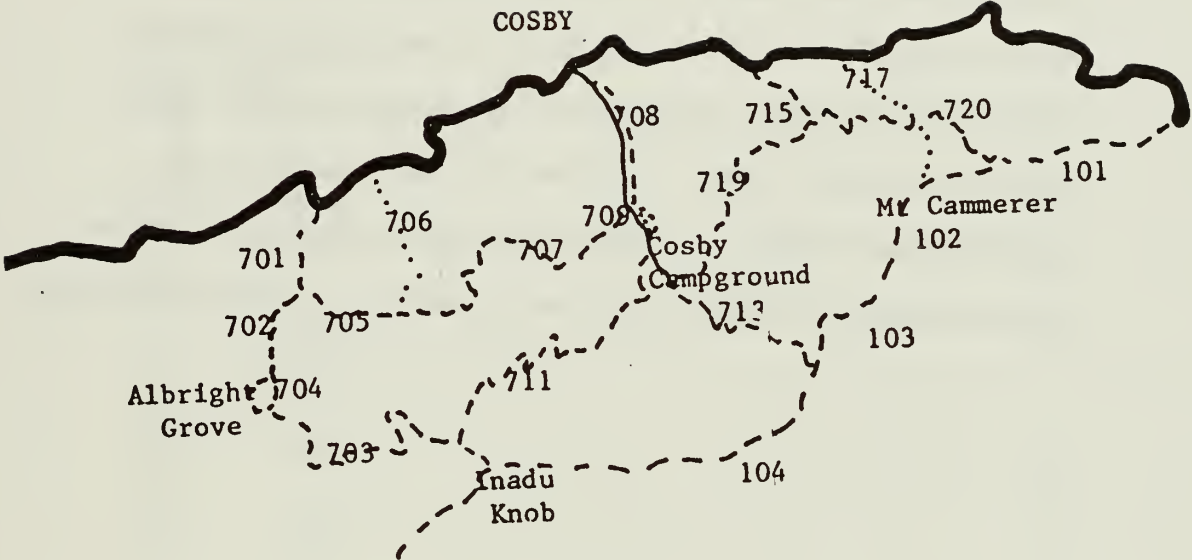
SECTION 7 - COSBY

Cosby, like LeConte, tends to be in fair to poor condition.

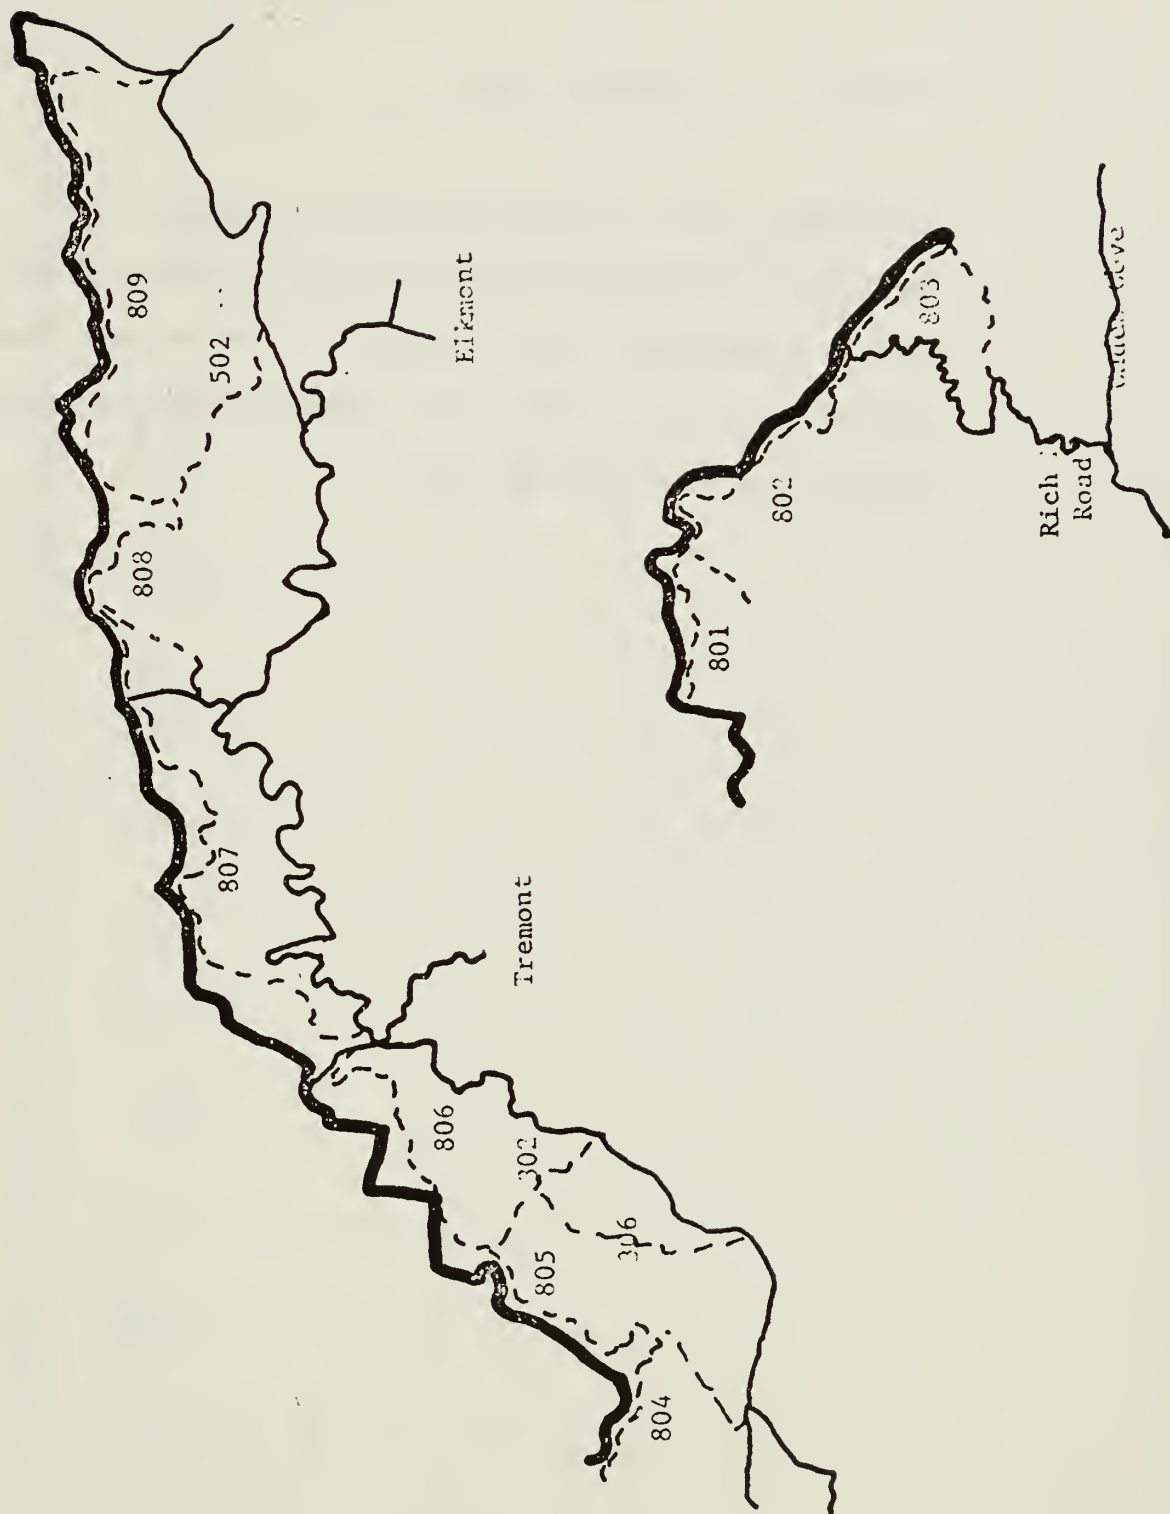
SECTION 8 - BOUNDARY TRAIL

The Boundary Trail is in good condition throughout. Bank erosion is the only major problem, and it is worst near Rich Mountain Tower (804). There are some ruts and exposed roots in the Cove Mountain area (809), with these two sections probably the only ones near carrying capacity.

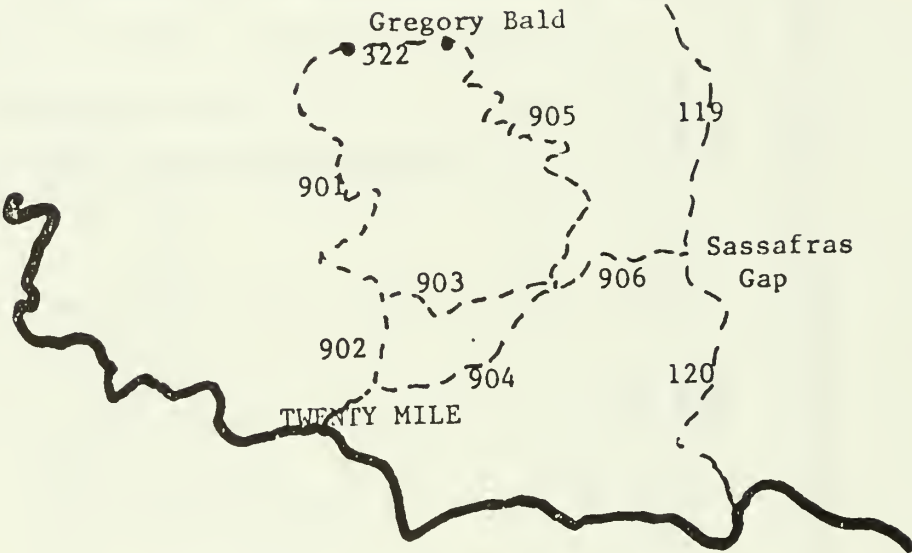
Section 9 - Twenty Mile

The only trail in the Twenty Mile area with really severe erosion problems is 906, the former jeep road to Shuckstack Firetower. The surface is water eroded and rutted. Careful attempts to keep up with water erosion in this section should keep most of the trails in good condition.

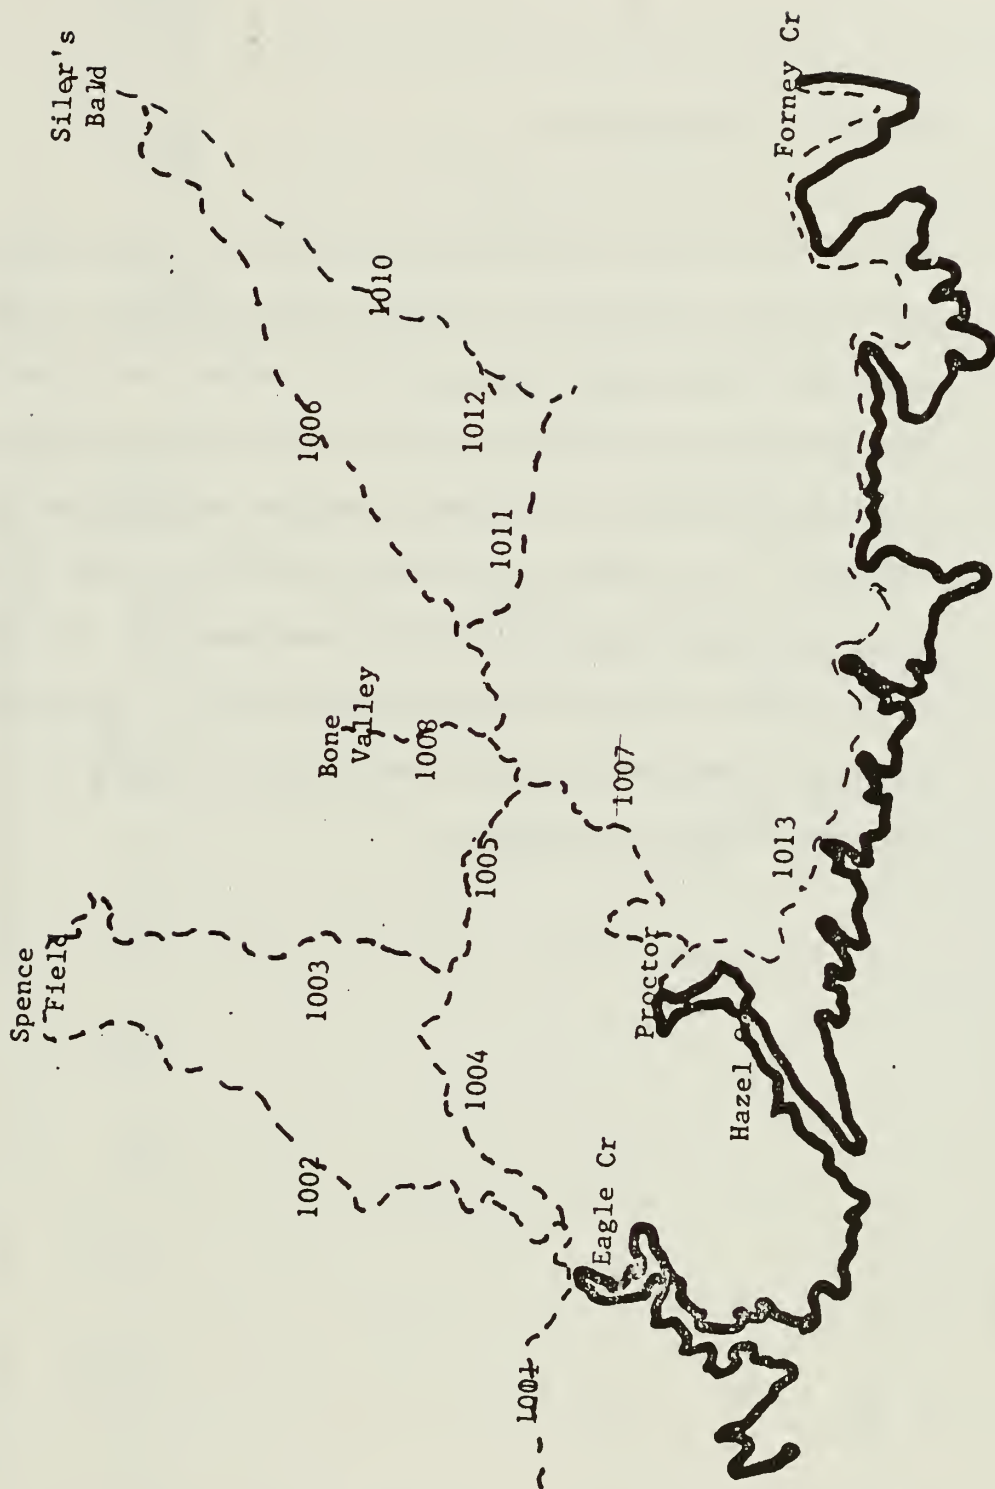
SECTION 10 - HAZEL CREEK

Section 10 is also in good-to-fair condition. The worst trail in the area is the former jeep road (1011) from Hazel Creek to High Rocks. The trail is water eroded, rutted, muddy, and has much exposed rock. The creek runs in the trail, implying that proper maintenance in its present position on the slope may be impossible. The upper end of Hazel Creek Trail (1006) is very steep and already has problems with water erosion. The Lake Trail (1013) is in generally good condition, but some stretches are badly routed and need to be moved before a trail cut is made and traffic is increased.

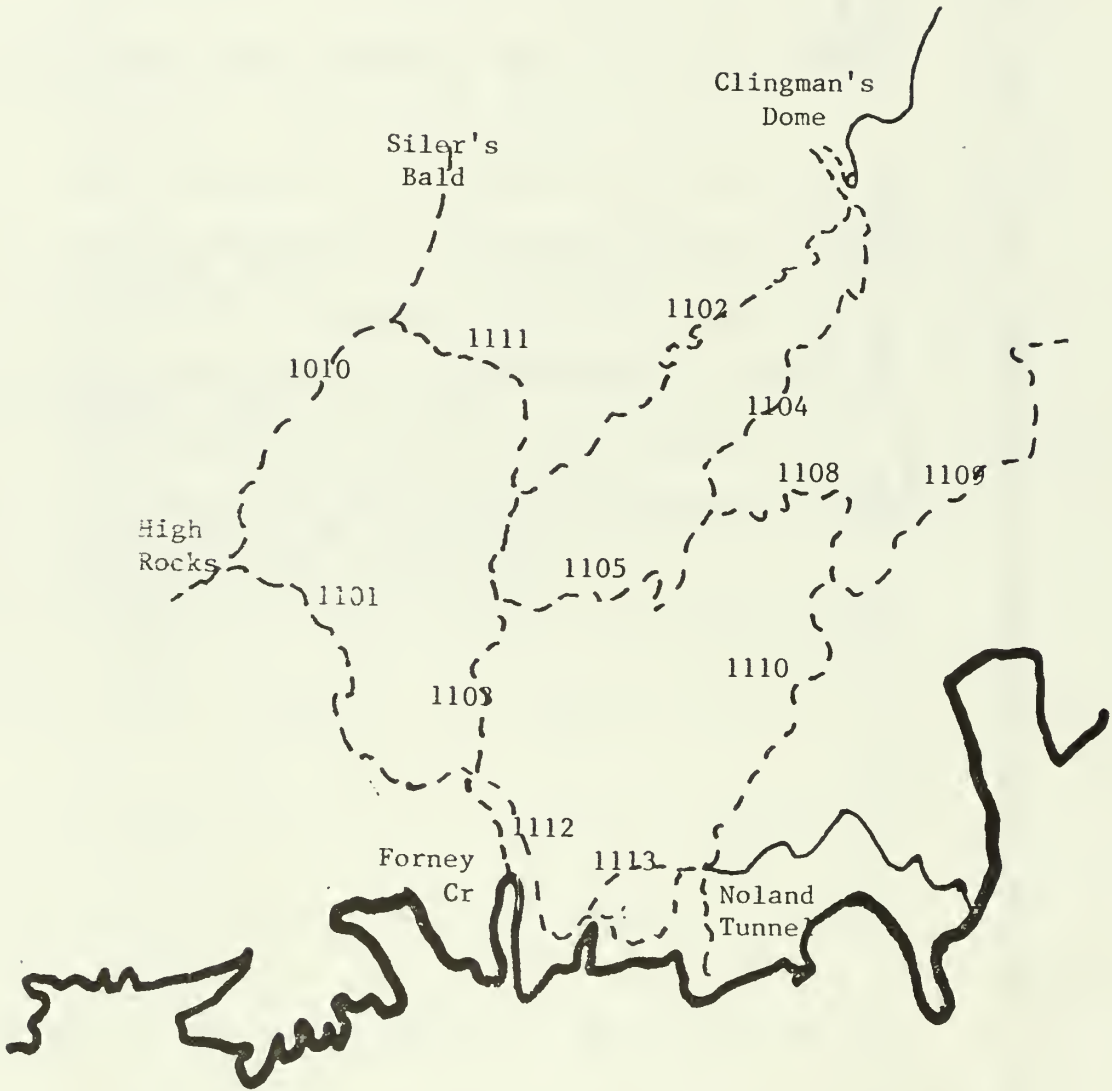
SECTION 11 - FORNEY CREEK

Forney Creek section has several problem areas. The trail to Andrews Bald (the upper end of 1104) is one of the worst in the park. It is deeply rutted and has mudholes and exposed roots. It is also badly widened in places. Conditions improve below the bald but there is still some water erosion. Forney Creek Trail (1102) is also water-eroded at the upper end. The horse trail cutoffs are steep in places and, although new, are developing local problems with rut and mud. The upper end of Noland Creek Trail (1109) is very muddy and there are problems with drainage. The Lake Trail (1112) is generally in good condition, but there are local problems with horse plow and water erosion, especially near Forney Creek. The horse cutoff (113) is rutting on steeper slopes. The trail to High Rocks (1101) has problems with rut and horse plow, particularly at the steep upper end.

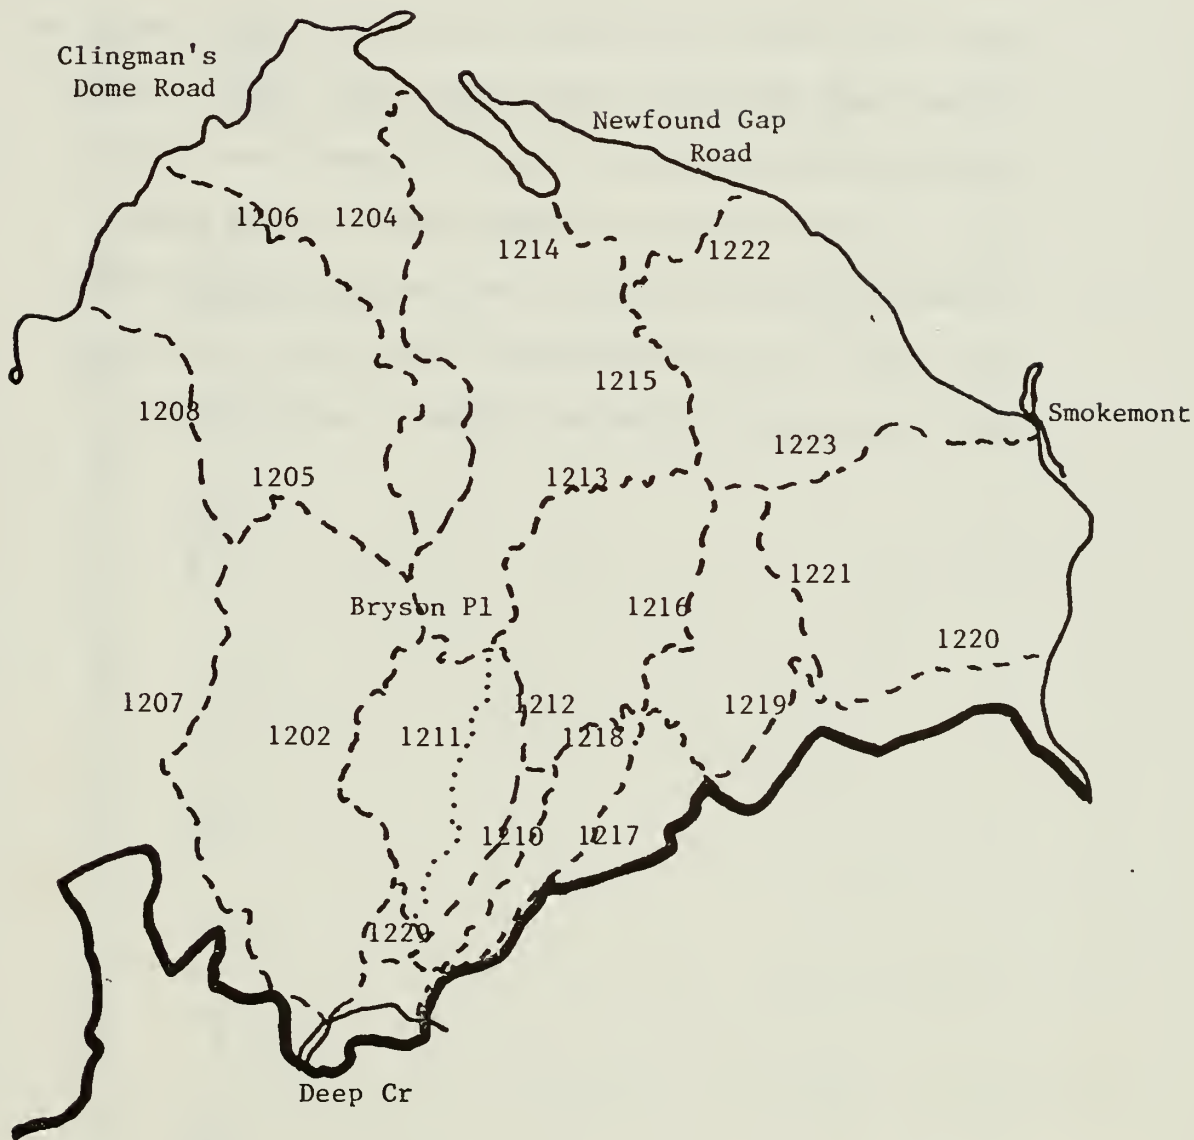
SECTION 12 - DEEP CREEK

Many of the trails in Deep Creek section are in good condition, although Deep Creek Trail itself (1202, 1203, 1204) is having problems with water erosion, mud, and exposed roots. The trail through Cooper Creek drainage (1218) is also having problems with water causing rut and mud, as is Mingus Creek Trail (1220). The unfinished motor nature trail (1227) has bank erosion and is beginning to slump in a few places.

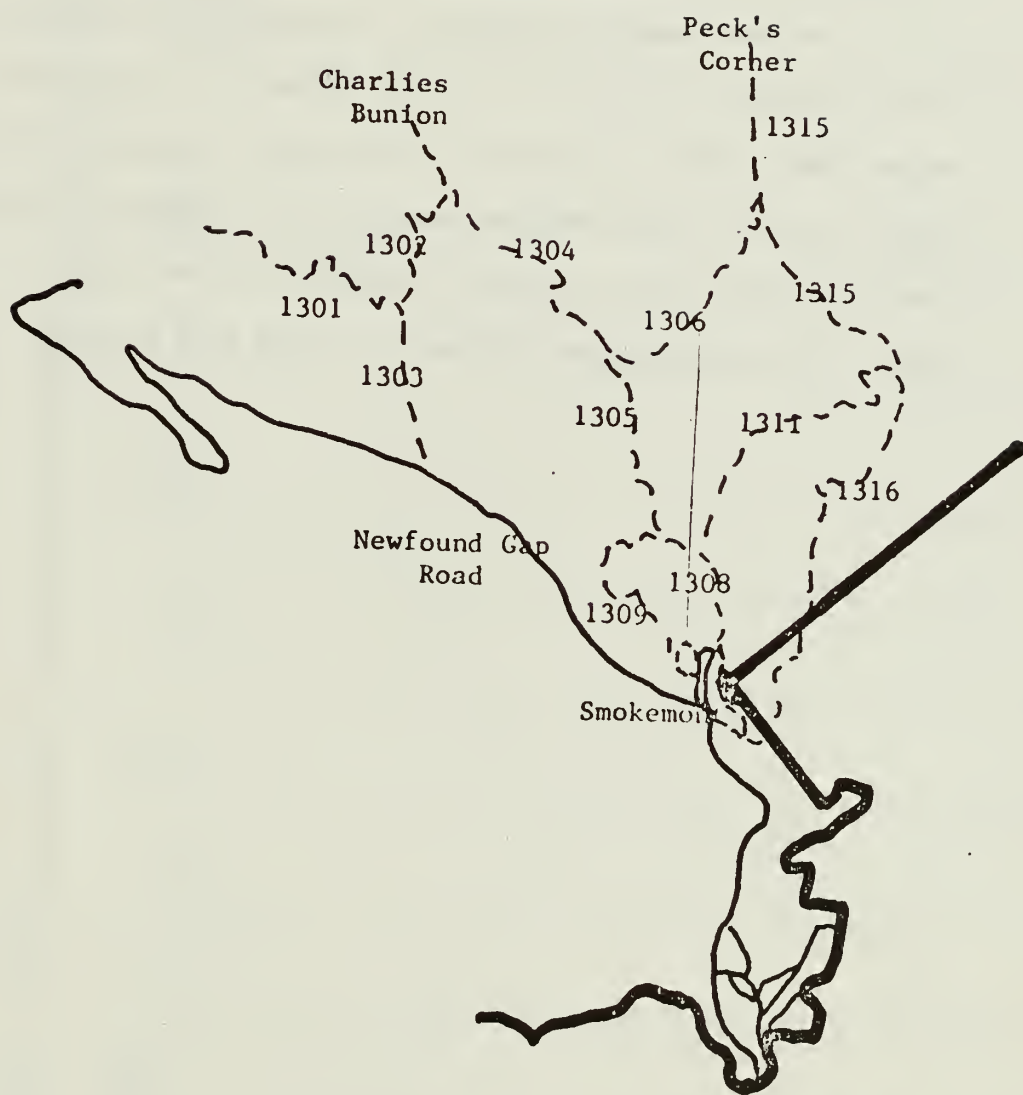
SECTION 13 - SMOKEMONT

The Smokemont section tends to have erosion problems in the steeper sections near the ridge tops. Richland Mountain Trail (1304) has water erosion and rutting, as does the upper end of Tawaha Creek (1306). A section of the trail to Kephart Shelter (1303) is water eroded and has exposed rock. Some of the lower elevation trails which are used primarily by horses (1312, 1313, 1314) have problems with mud, rut, and bank erosion.

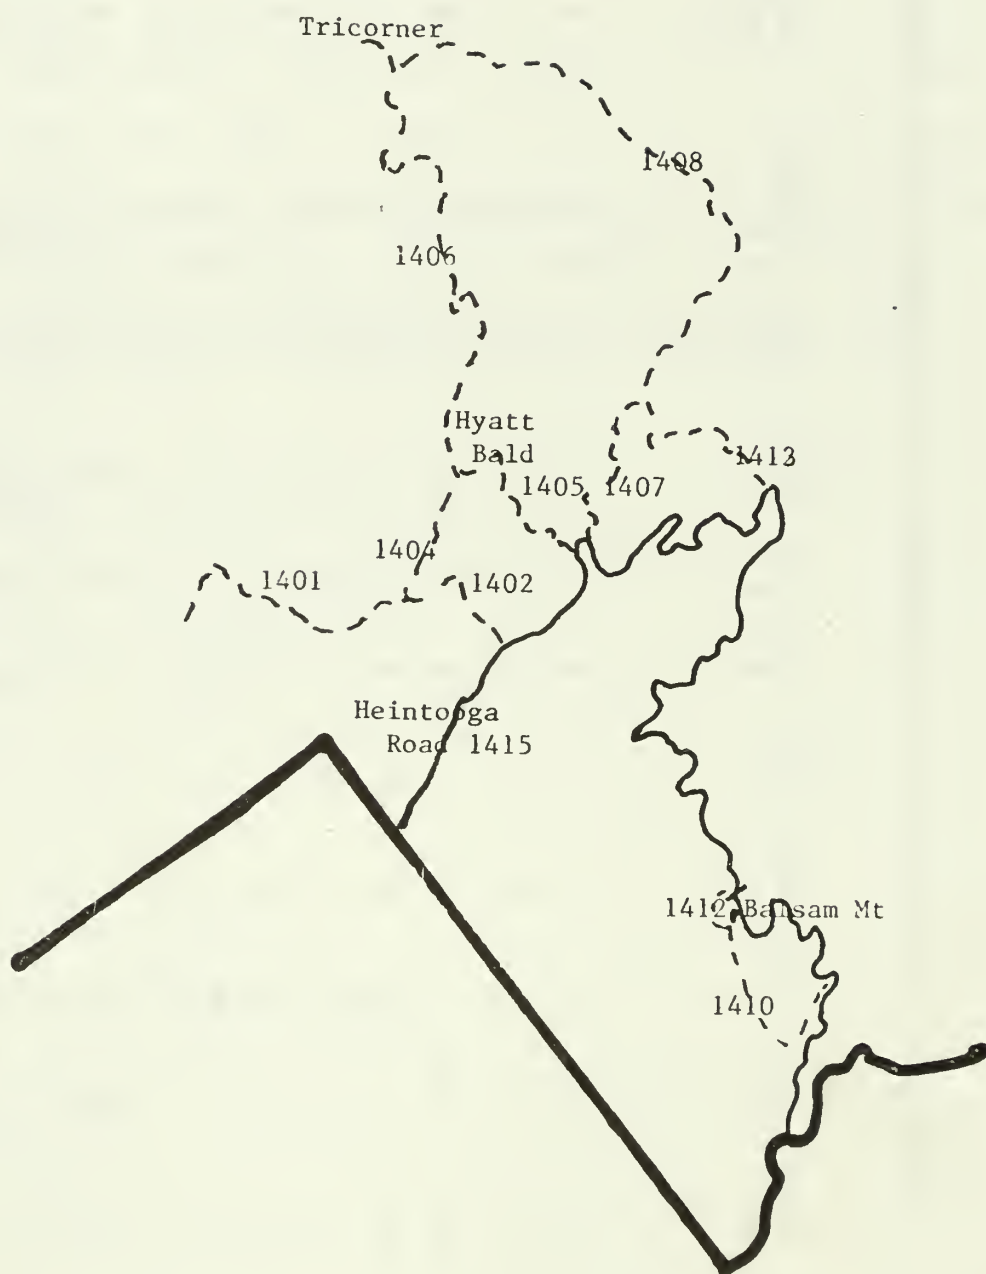
SECTION 14 - HEINTOOGA

Heintooga section has a large area of spruce-fir forest which influences conditions even on moderately used trails. The trail from Tricorner to Hyatt Bald (1406) is the worst of the longer trails in the section. It has large amounts of mud, rut, and tree roots, especially in the sections that run along the ridge top. Balsam Mountain (1408) also has local areas of mud, rut, and roots. Both trails should be considered difficult to maintain. The jeep trail from Heintooga Road to Hyatt Ridge (1402) is water eroded and has much bare rock. The short trails near Balsam Mountain Campground are erosion sensitive and rutted on the steeper sections.

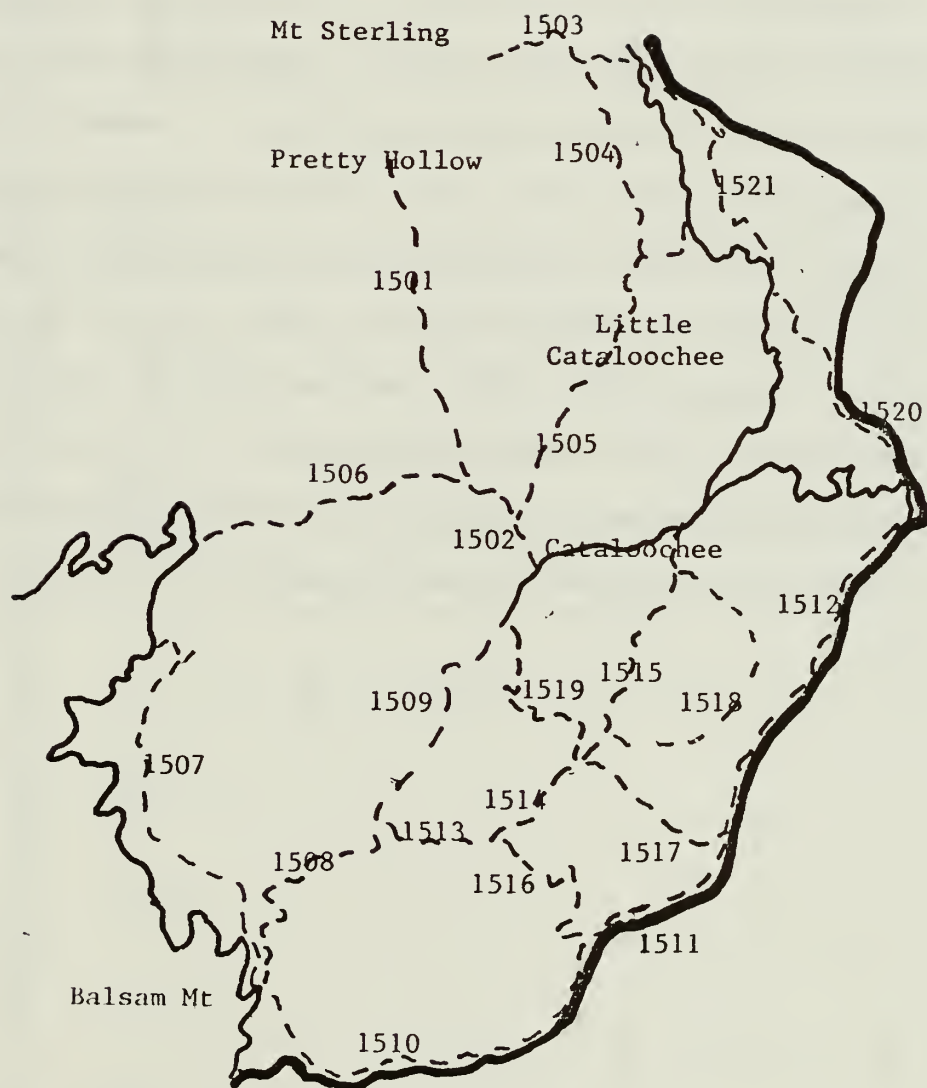
SECTION 15 - CATALOOCHEE

A substantial portion of the trails in Cataloochee area have problems with mud and horse plowing. Probably the worst is the middle section of Cataloochee Divide (1511). A number of others, including 1516, 1513, 1515, 1519, 1501, and 1506 fall into this category. The trail to Spruce Mountain Tower (1507) has both typical spruce-fir problems with mud, roots, and rut, and evidence of horse damage, as does 1508. Only two of the 21 trails in this section had all their erosion ratings above 3.0. Of the sections on the North Carolina side of the park, Cataloochee has the most problem trails and needs the most attention from management.

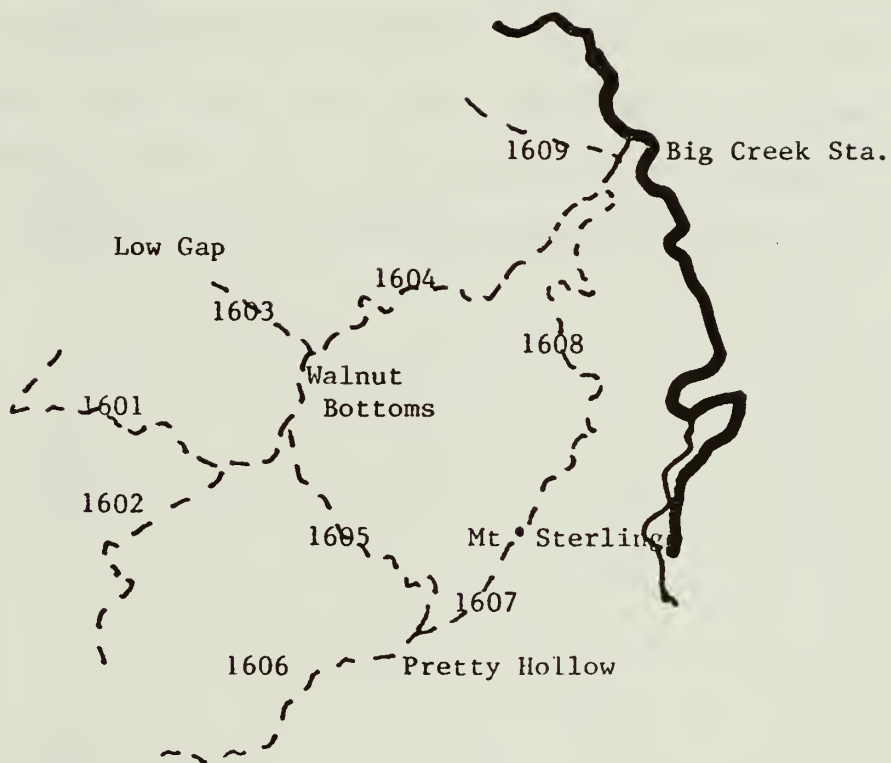
SECTION 16 - BIG CREEK

The most eroded trail in the Big Creek area is the trail between Mount Sterling and Pretty Hollow Gap (1607), which has uncontrolled water erosion, mud, and exposed roots. The trail to Low Gap (1603) and Swallow Fork Trail (1605) both are water eroded, and Swallow Fork has a number of mudholes.
